Record of Concern/Record of Response for October 27, 2006

Summary

This record is being drafted to document concern for environmental impacts associated with construction activities on the Falls Creek Hydro-electric project. Blasting in recent weeks has resulted in 4 slides into Falls Creek. The first slide occurred on October 6th and the most recent slide occurred on October 22nd. The slides have had minimal-moderate immediate impacts on fish habitat, however, slope instability and the threat of further mass wasting is a serious concern in all areas, including blasting areas scheduled for the near future. Two of the slides at the powerhouse area had direct impacts to anadromous fish habitat that may necessitate mitigation. Each of the 4 slides occurred as a result of bedrock blasting for service road construction. Each of these shots were conducted under circumstances where nothing, or a very narrow protective berm existed between the planned shot and the Falls Creek canyon wall. For the purposes of this report these type of shots will be referred to as “daylight shots” (see figures 1 and 2). *A preliminary report on the first two slides was provided via e-mail (including photos)

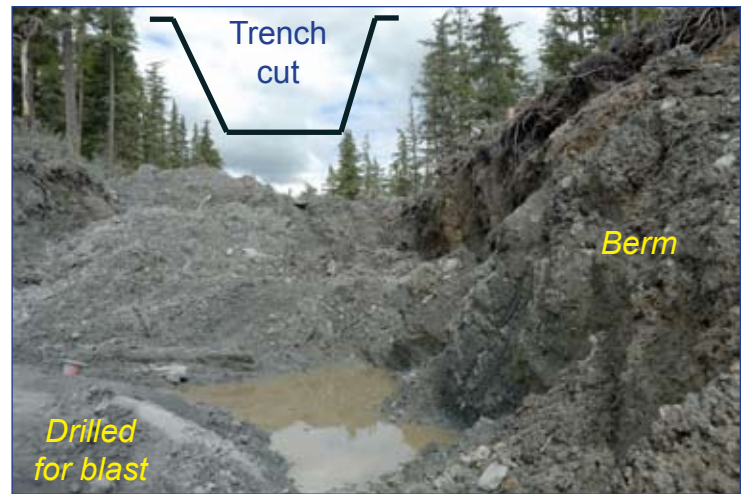
Figure 1: Berm shot in the Blueberry Hill trench cut.

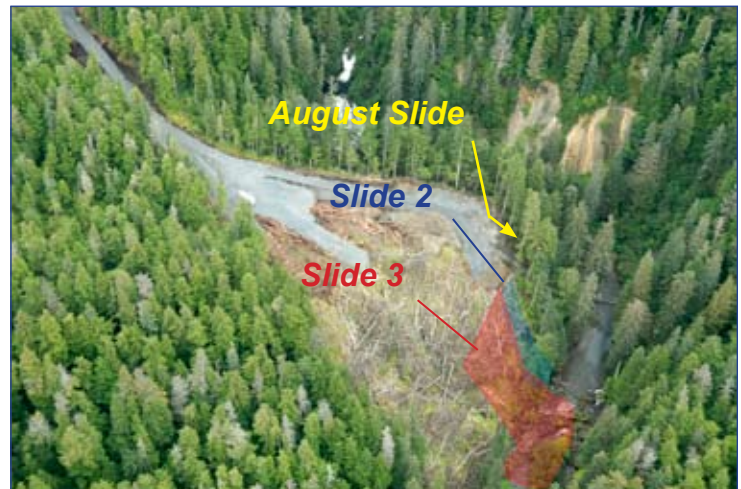
Slide 3 into the creek occurred at the powerhouse site on October 19th (see figure 4.0, 4.1, 4.4 and 4.5). Like the slide at Blueberry Hill, this slide also occurred as a result of a daylight shot that was at least partially unavoidable as the road was coming out of the bench cut corner above Falls Creek to descend into the powerhouse valley. Slide 3 occurred in two parts: 3.1) the forested slope immediately between the shot and Falls Creek slid down into the creek, and 3.2) the “topsoil” in the powerhouse valley gave way and slid into the creek when loaded with shot rock. The blasting plan for this area was to lift and throw the rock away from the canyon wall and into the powerhouse valley. The shot went according to the plan but the forested slope was shaken enough to still result in slide 3.1 and the down slope loading of the powerhouse valley unexpectedly resulted in slide 3.2.

Figure 4.0: Aerial view of the powerhouse area that shows the August slide and the locations impacted by slide 2 and slide 3.

Slide 3 into the creek was the largest thus far and resulted in approximately 2,500 yards of topsoil and shot rock covering the creek, as well as several logs and trees. Although potential spawning gravels were not mapped in this location in 2000, recent photos indicate that potential spawning gravels, especially for coho salmon, were likely present in the area now covered by the slide (see Appendix 1 for a figure excerpted from Flory 2000, Resident Dolly Varden, Anadromous Fish Species and Benthic Invertebrates of the Falls Creek Area, part of the PDEA). The impacted area included an island in the center of the stream and a channel along the east side of the island. The terminal lobe of the slide now rests on top of this island and the channel on the east side was completely buried. No mitigatory actions have occurred thus far. Jackie Timothy of the DNR met with me and the project manager on-site to assess impacts and begin a discussion on possible mitigation actions. Plans for mitigation are ongoing and will be described in further detail in a subsequent report.

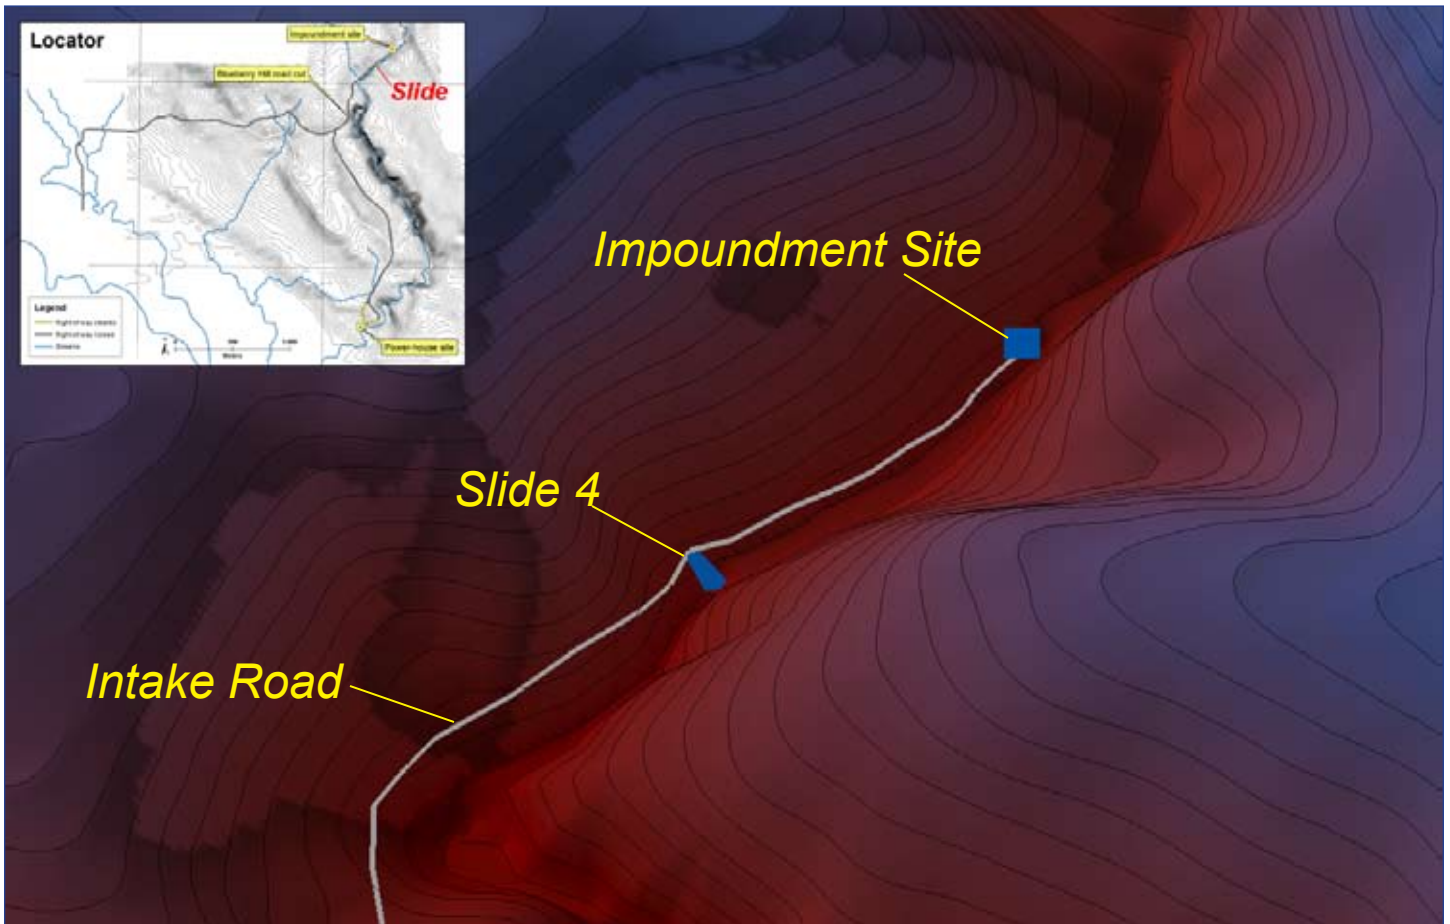
Slide 4 into the creek resulted in a small amount of mud and shot rock sliding ~ 20' down from the intake road into the creek (see figures 5.1 and 5.2). Minor impacts to resident fish habitat occurred as well as a short-term increase in downstream turbidity. Considerable blasting work remains along this stretch of service road and at the impoundment site (see figures 5.1 and 5.3). With the exception of the shot that resulted in slide 4, current blasting plans along the road appear to be working fairly well in keeping side-slope material out of the creek. It is important to keep in mind that blasting in such close proximity to the stream and with such unstable materials on the proximal slopes makes for an extremely challenging working environment for the road builders. This was brought to the attention of FERC on-site during their September visit. That having been said, I am much less concerned with the minor impacts that may result from shooting the creek-side road and penstock grade than I am concerned about the potential for a very large mass wasting event during the development of the impoundment site.

Figure 5.1: Elevation model for the area around the intake road cut and impoundment site. One small slide has occurred here from blasting. The impoundment site will be especially difficult to blast.
